Consumer Product Service
Manager of Tehnical Support
FIELD CHANGE ORDER number **1A**

MODEL:2600A ATARI Video Computer System

Changing 12V radial lead capacitors at C241 and C242.

Consumer Product Service
Manager of Technical Support
UPGRADE BULLETIN

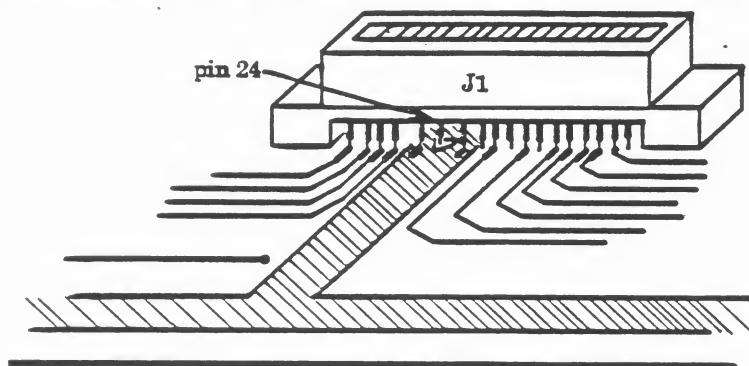
Figure 1. Pin 24 Isolation.

IT IS EXTREMELY IMPORTANT THAT PIN 24 OF J1 BE COMPLETELY ISOLATED FROM GROUND.

1. Remove the top cover of the CX5200.
2. Verify that the PCB Part Number is CA018087. (If it is not this number, there is no need for the modification. Reinstall cover, insert adaptor, go to step 13 and test.)
3. Remove both the top and bottom PCB shields.
4. Using either an X-ACTO knife or a Dremel tool (150 Bit), isolate Pin 24 of J1 from ground by making a "V" or "U" shaped cut in the trace on the component side of the PCB (See Figure 1). Be careful not to isolate Pins 23 and 25 from ground.

Use an Ohm Meter to verify that Pin 24 has been isolated from ground.

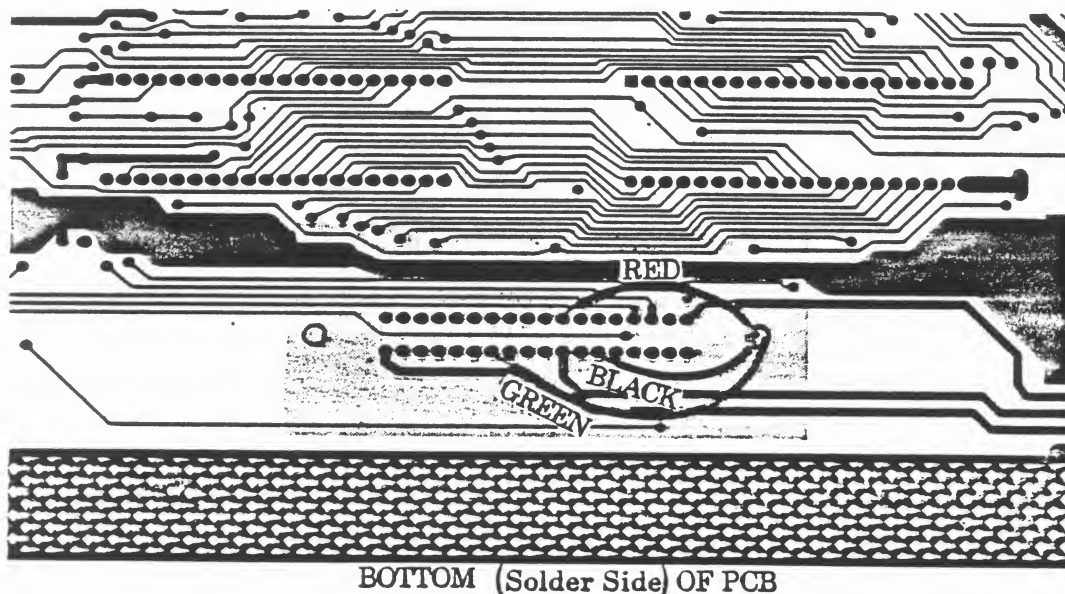
Figure 4. Wire Connection Diagram.

* = Take extra care to avoid connecting the RED wire to any ground pins. If the RED wire is grounded, the 5200 Power Adaptor will burn out.

- A. Solder Assembly 1 wire (BLACK) to Pin 24 of J1.
- B. Solder Assembly 2 wire (GREEN) to Pin 30 of J1.
- C. *Solder RED jumper wire to Pin 11 of J1.

After soldering, use an Ohm Meter to make sure that no solder bridges or shorts were formed adjacent to Pins 11, 24, and/or 30 of J1.

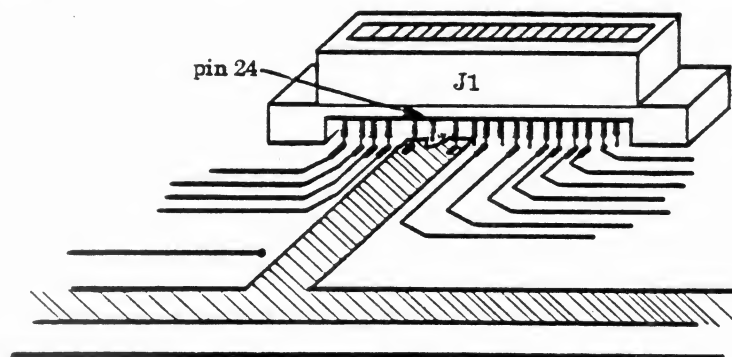
Figure 1. Pin 24 Isolation.

IT IS EXTREMELY IMPORTANT THAT PIN 24 OF J1 BE COMPLETELY ISOLATED FROM GROUND.

NOTE: The ground plane does not go all the way under the cart socket so you can cut it as stated.

1. Remove the top cover of the CX5200.
2. Verify that the PCB Part Number is CA018087. (If it is not this number, there is no need for the modification. Reinstall cover, insert adaptor, go to step 13 and test.)
3. Remove both the top and bottom PCB shields.
4. Using either an X-ACTO knife or a Dremel tool (150 Bit), isolate Pin 24 of J1 from ground by making a "V" or "U" shaped cut in the trace on the component side of the PCB (See Figure 1). Be careful not to isolate Pins 23 and 25 from ground.

Use an Ohm Meter to verify that Pin 24 has been isolated from ground.

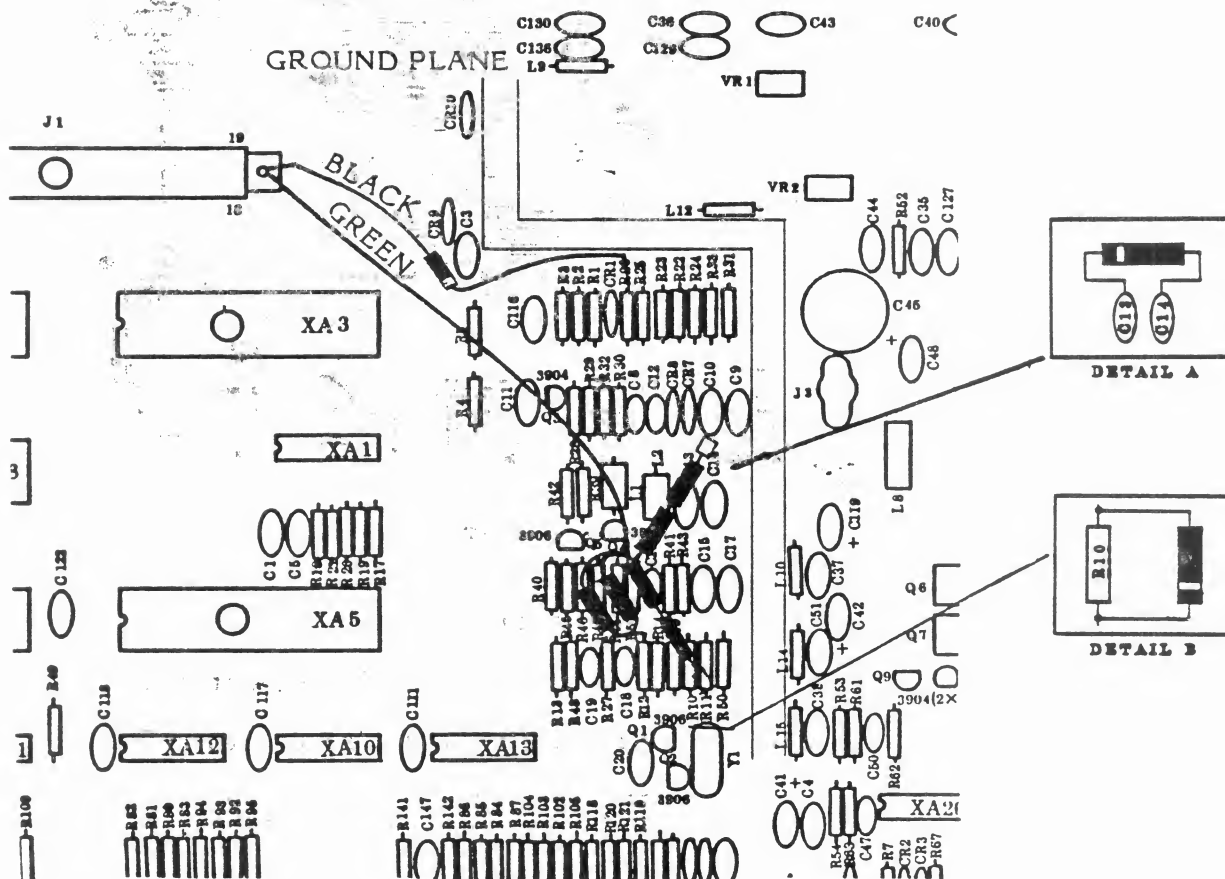
Figure 3. Retrofit Diagram

NOTE: Ensure that assy. 2 is not positioned in such a way that when the shield is placed back on the unit the components short against the shield. If it does, this may result in damage to the 5200 or cartridge adaptor.

6. Using Figure 3 as a reference perform the following:

- A. Solder cathode of D1, Assembly 1 to R26.
- B. Pass Assembly 1 wire, (BLACK) through hole in J1.
- C. Solder cathode of D4, to C13 (See Detail A).
- D. Solder anode of D4, to C14 (See Detail A).
- E. Solder D5 to R10 (Note polarity). See Detail B.
- F. Solder cathode of D2, Assembly 2 to C10.
- G. Solder cathode of D3, Assembly 2 to R11.
- H. Solder R3, and C1, Assembly 2 to R12.
- I. Pass Assembly 2 wire (GREEN) through hole in J1.

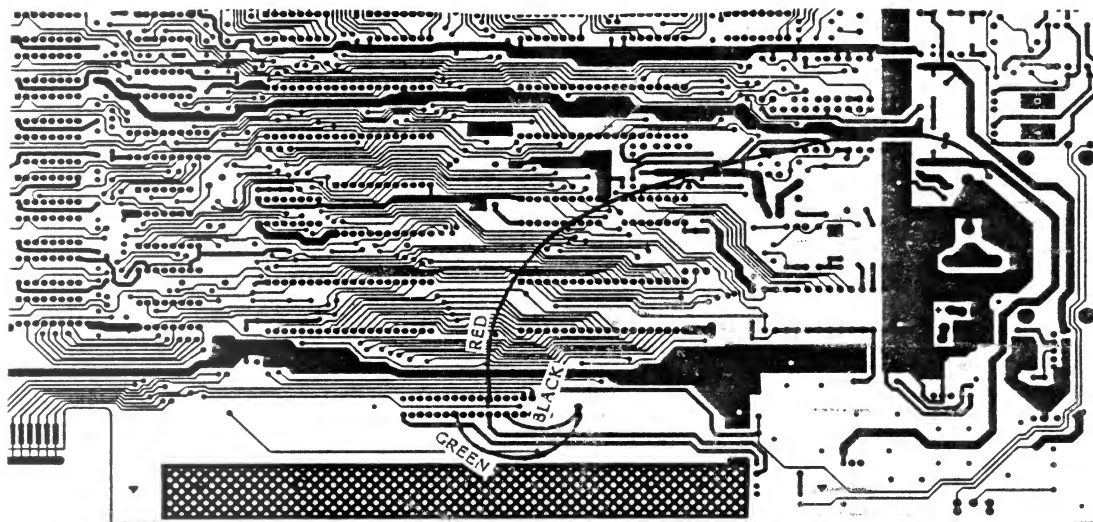
Figure 4. Wire Connection Diagram.

* = Take extra care to avoid connecting the RED wire to any ground pins. If the RED wire is grounded, the 5200 Power Adaptor will burn out.

- A. Solder Assembly 1 wire (BLACK) to Pin 24 of J1.
- B. Solder Assembly 2 wire (GREEN) to Pin 30 of J1.
- C. *Solder RED jumper wire to Pin 11 of J1.
- D. *Solder other end of RED wire to bottom leg of L8.

After soldering, use an Ohm Meter to make sure that no solder bridges or shorts were formed adjacent to Pins 11, 24, and/or 30 of J1.

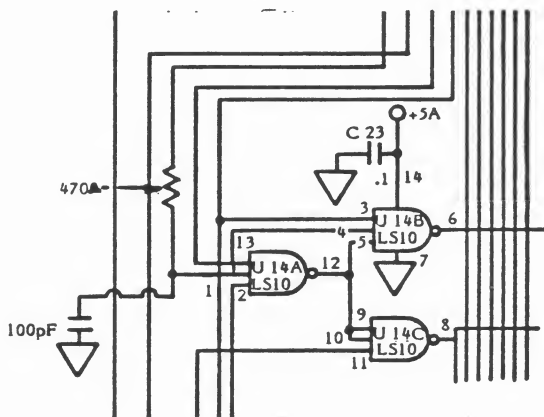
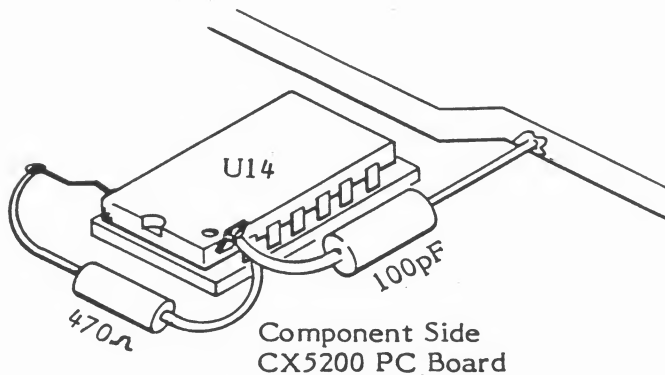
Rockwell MPUs with date code of 8250 and later (stamped with the letters RC) have a timing defect.

A factory modification adds an R-C network on the component side of the CX5200 PC Board, at IC U14A (pin 1) and U6A (pin 4) (see Figures 1 and 2).

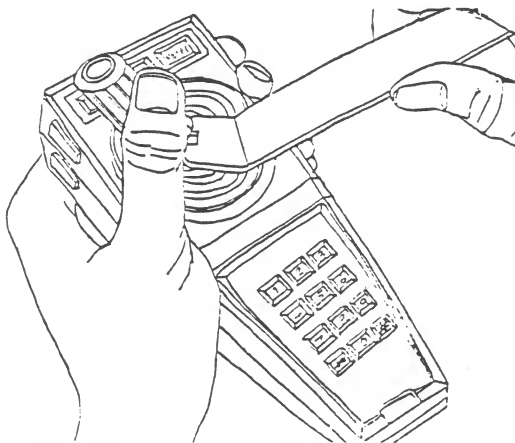
Figure 1. Controller Knob Removal.

It has been learned that removal of the 5200 Controller Knob is difficult.

Push the knob shaft into one of the corners of the top housing opening. Push down the boot with the tool to expose the shaft. Push the tool toward the shaft until the shaft is inside the notch of the tool's head (See Figure 1). Now, gently lever the tool, and the knob will pop off.

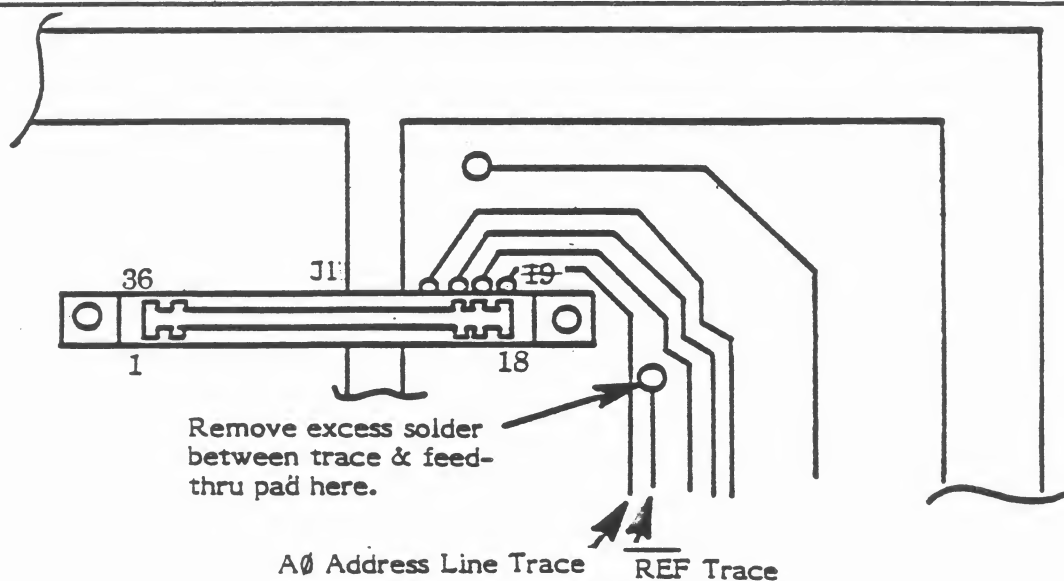
Figure 1. 5200 PCB Solder Side at J1

Some 5200 units display a blank dark screen or a screen with garbled information. The probable cause for either of these symptoms is an intermittent solder short (bridge) on the PCB between the A0 Address line trace and the feedthru pad of the REF Line trace (near connector J1).

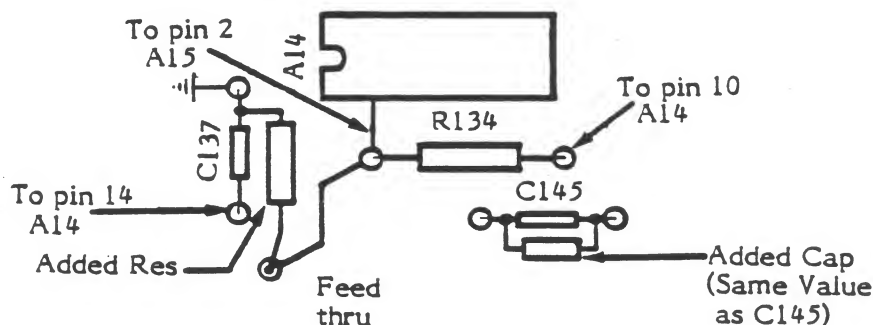
Figure 1. Resistor/Capacitor Fix

The timing of some Signetics I.C.'s causes RAM information to be distorted. This results in a scrambled screen display or worse - no video at all.

C145 (C014179-24) should be paralleled with another 390pf capacitor (C014179-24) and a 470 Ohm resistor (14-5471) be added from C137 to R134 (See Figure 1).

If the unit still displays a faulty screen, swapout A16 and A17 with another vendor's component. DO NOT USE A SIGNETICS I.C.

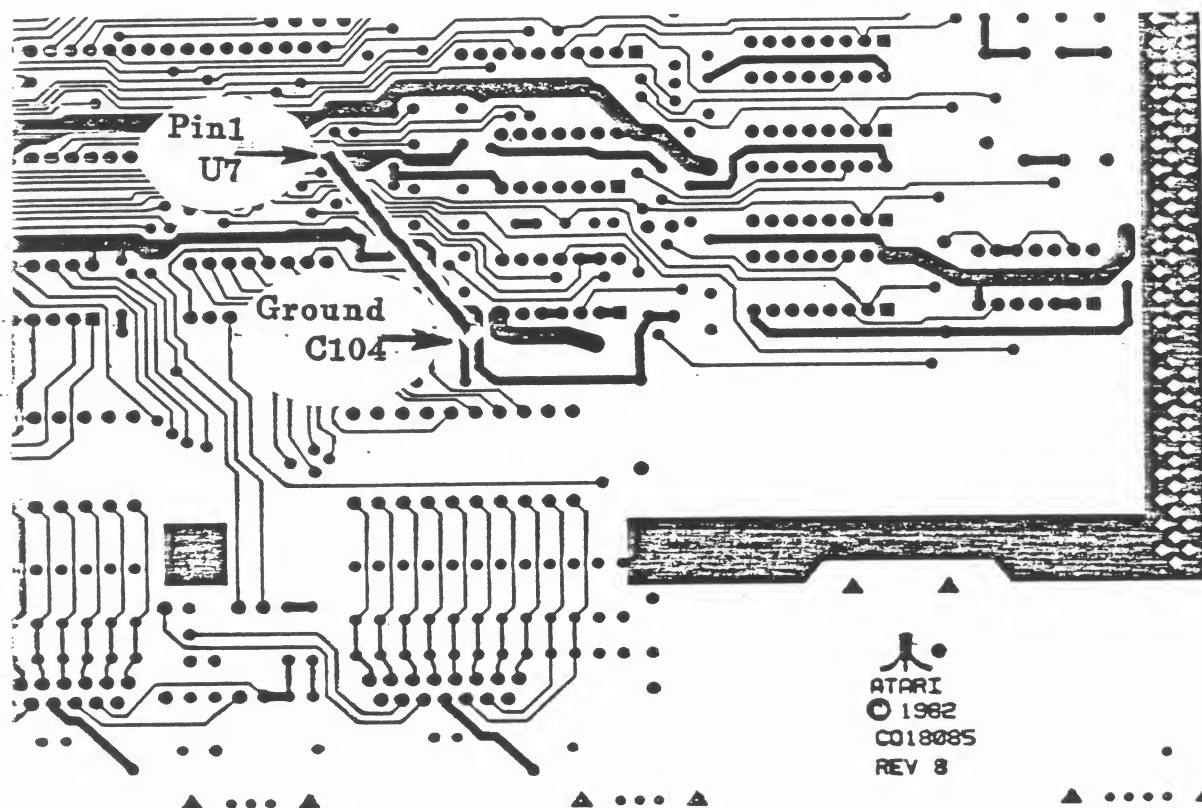
Figure 1. Sleeve Buss Wire Placement

Some 5200 PCB's demonstrate paddle jitter caused by a ripple on the +5v power supply to the POKEY IC (U7), and an inadequate ground trace at Pin 1 of U7.

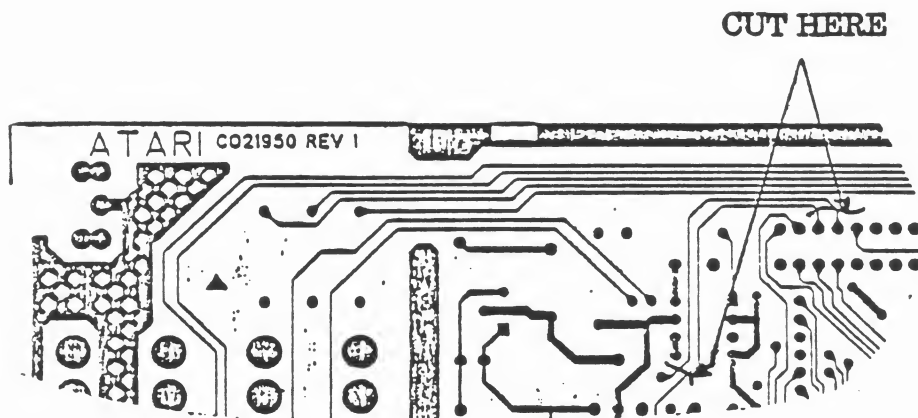
Figure 1. Trace Cuts

NOTE: Some CX55's may have been modified during production. Use these procedures to make certain the jumpers have not become detached.

1. On the solder side of the Adaptor PCB, carefully cut the traces shown in Figure 1.
